Case Studies

Bellsgate & Queens Square Shopping Centres

King Georges Close

Southend Street Properties (SHDF)

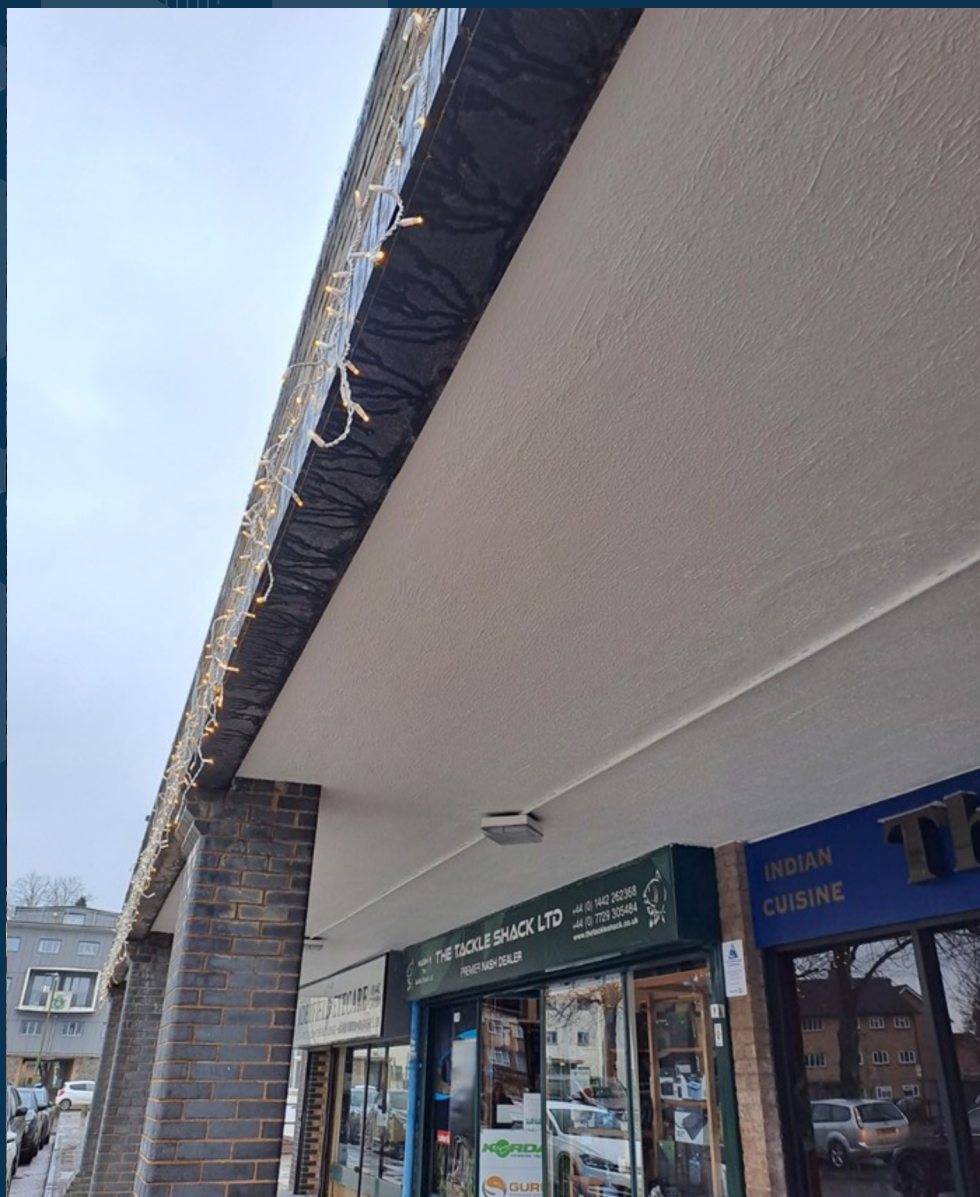
Bellsgate & Queens Square Shopping Centres

We were engaged by Dacorum Borough Council in September to deliver a programme of repairs and refurbishments to their commercial and retail properties. Commencing in October 2023 with Bellsgate and Queens Square Shopping Centres.

- Concrete and brickwork repairs.
- Repairs to insitu concrete repairs.
- Application of anti-carbonisation and corrosion management systems.

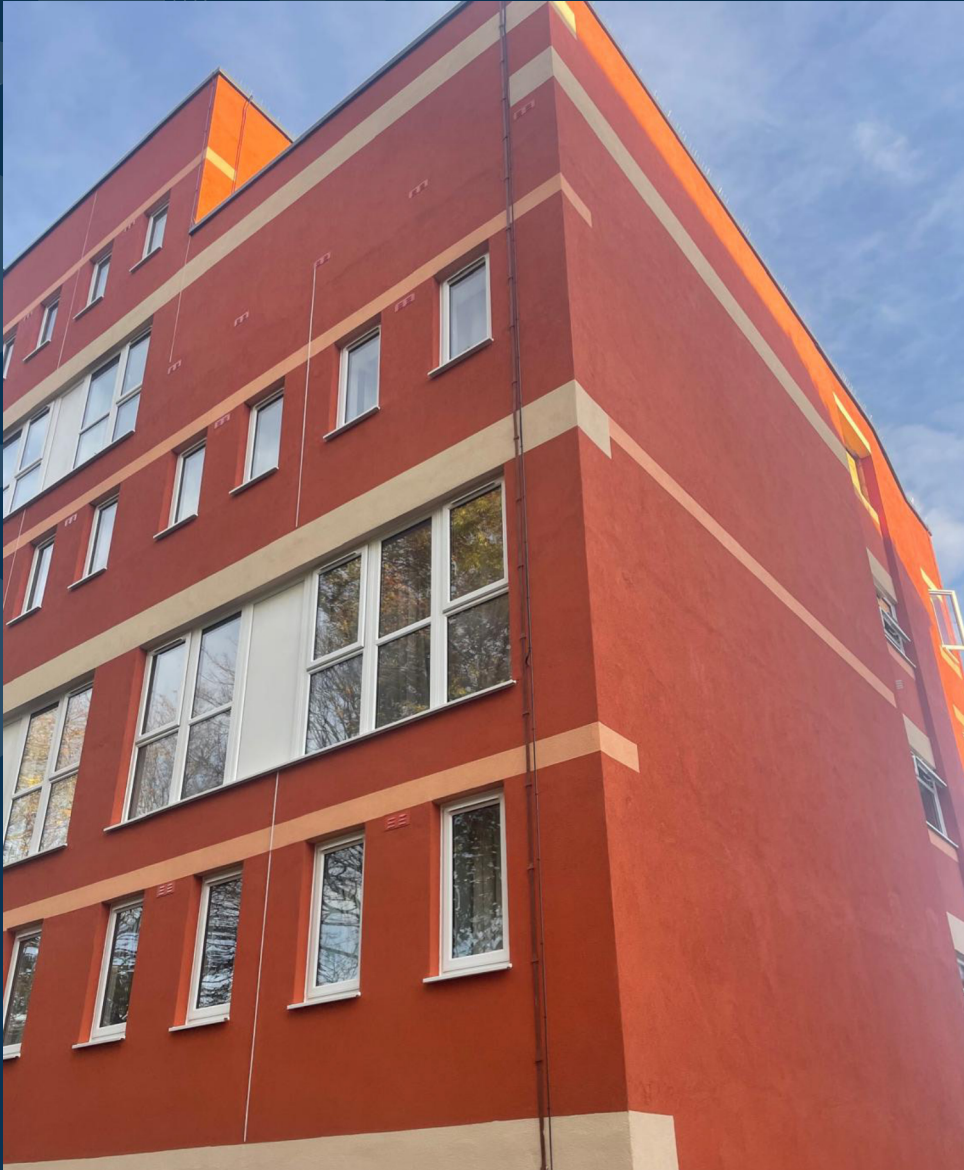
BTS Special Works were appointed in July 2022 to complete repairs, treatments and EWI installation to the façade of 1-40 King Georges Close for Moat Housing.

During the initial surveys, the team identified the existing cavity wall ties were insufficient to take the weight of a new EWI system. We worked closely with the client to identify and agree the installation of Helifix Wall Tie system to support the new system.

To prepare the façade for the EWI installation, the current wall coatings were stripped and the concrete and brickwork were repaired to make good the surface. The new structural ties were then installed prior to the EWI installation.

- Installation of Helifix Wall Ties.
- Coating removals with associated concrete and brick façade repairs.
- Application of protective coatings.
- External Wall Insulation.
- Liquid coatings to walkways.

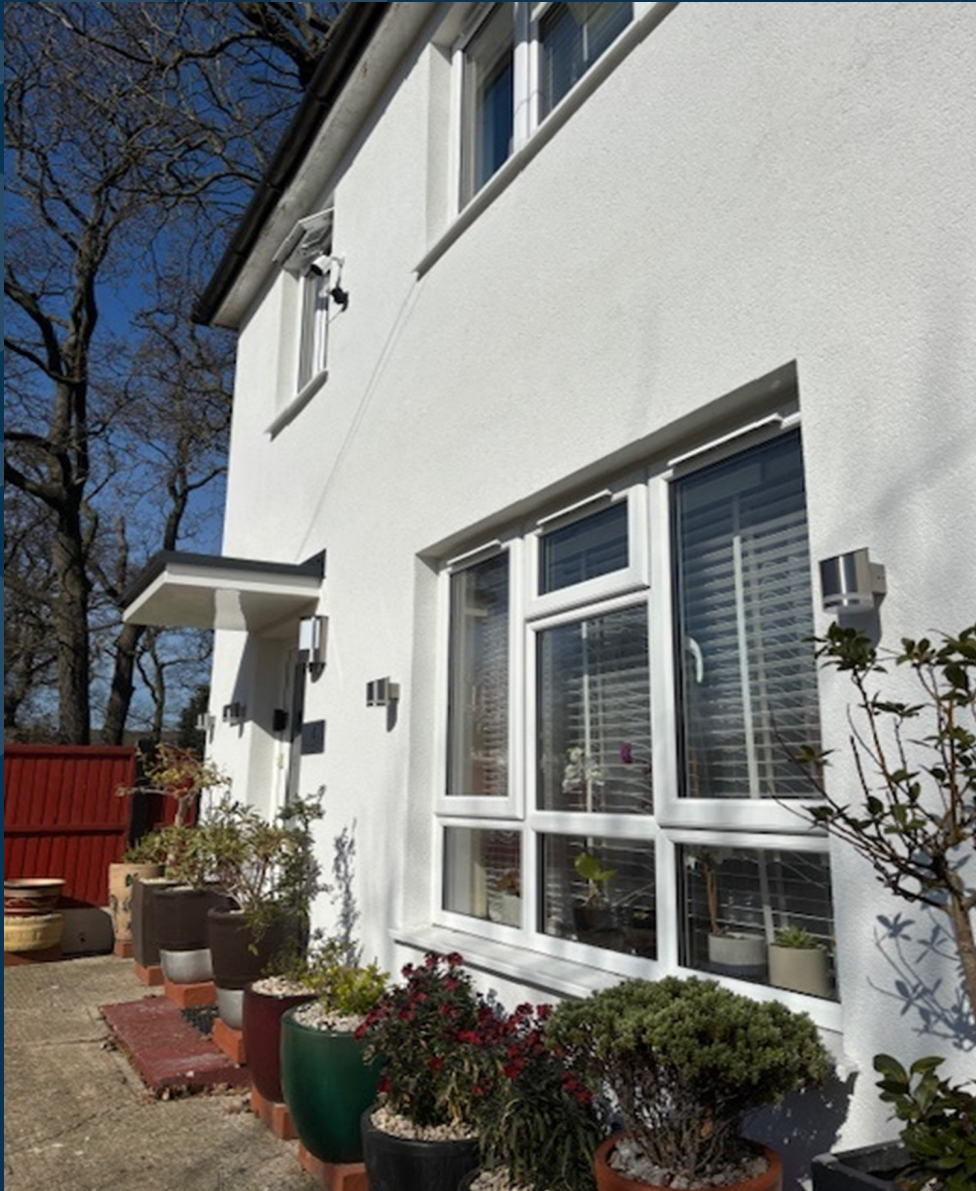
Southend Street Properties (SHDF)

The work consisted of the installation of a K-System EWI system with EPS board, basecoat, mesh and silicone render finish (in residents' chosen colour). Due to EPS boarding being specified, BTS were required to install all necessary firebreaks in accordance with Fire Safety Regulations. Additionally, each property had a new fascia, soffits & guttering along with replacement door canopies where applicable, and aluminum cill extensions to all existing windows.

- Installation of new K-System External Wall Insulation.
- Renewal of fascia, soffit and guttering.
- Renewal of existing front entrance door canopies.
- Installation of roofline firebreaks and insulation.
- Renewal of existing defective bay roofs.

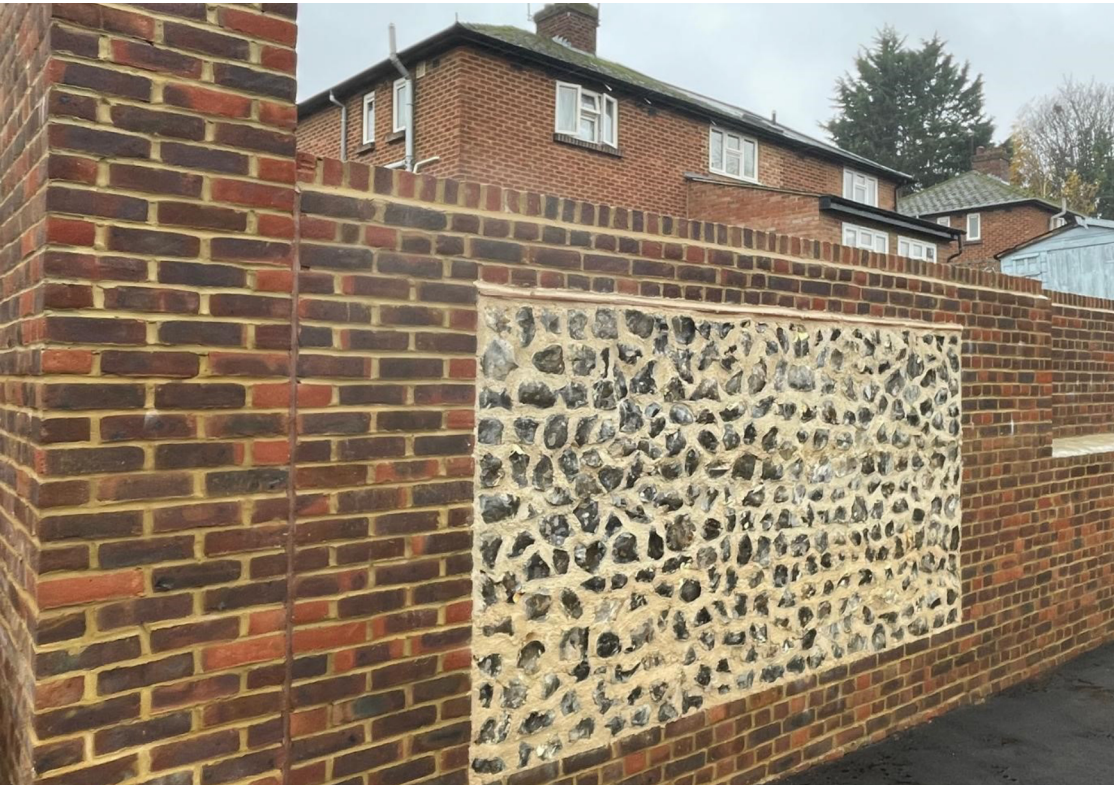
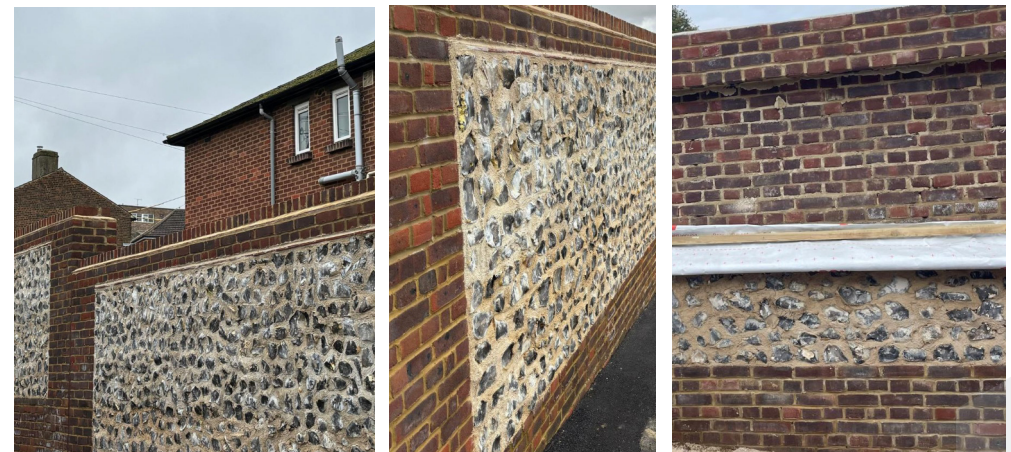
Highfield Road, Boundary Wall

BTSSpecial Works were engaged to survey, remove and reinstate the boundary wall at Highfield Road, Berkhamstead. The original, listed Knapped Flint Render boundary wall had become structurally unsound due to faulty foundations and posed a serious safety risk to neighbouring residents and the public.

Following surveys, we worked collaboratively with the client's engineer to develop the designs for the new foots to ensure structural stability, taking into account modern regulations for stepping the construction along the hillside.

The resulting new installation is a stable and safe boundary wall, built using modern methods, whilst retaining the Knapped Flint rendering to reflect the aesthetic of the original boundary wall.

- Deconstruct structurally unsafe knapped flint render boundary wall.
- Installation of new foundations.
- Construction of new boundary wall in sympathetic aesthetic.
